Pascal POMAREDE, Fodil MERAGHNI, Laurent PELTIER, Stéphane DELALANDE, Nico Felicien DECLERCQ - Damage Evaluation in Woven Glass Reinforced Polyamide 6.6/6 Composites Using Ultrasound Phase-Shift Analysis and X-ray Tomography - Journal of Nondestructive Evaluation - Vol. 37, p.12 - 2018

Damage Evaluation in Woven Glass Reinforced Polyamide 6.6/6 Composites Using Ultrasound Phase-Shift Analysis and X-ray Tomography

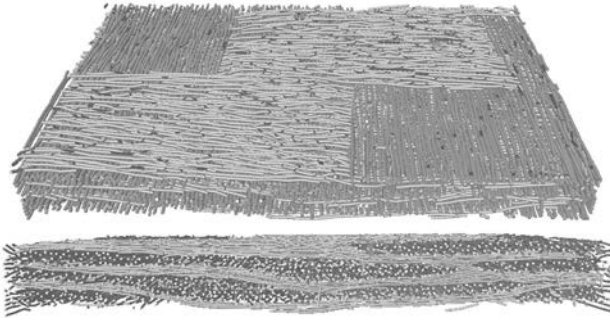
Fig. 1 Overall 3D mesostructure of the studied composite consisting of 2/2 twill weave fabric reinforced polyamide 6.6/6 matrix

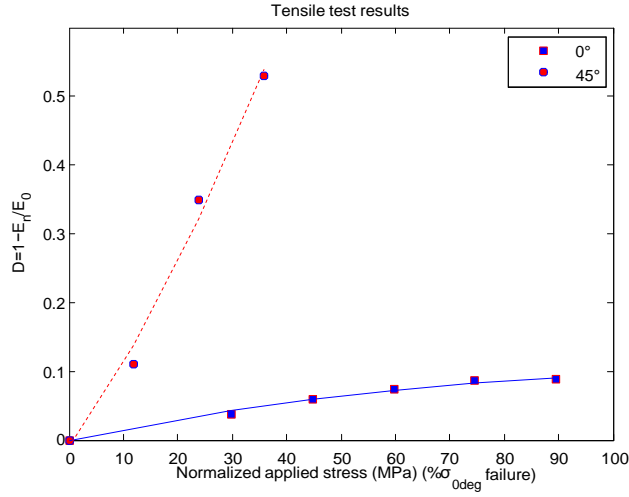
Fig. 6 Evolution of the the damage for 0° and 45° sample's configurations. The damage is estimated from the Young's modulus reduction for different applied stress levels

This is particularly clear for the evolution of the damage estimated on the elastic modulus reduction when the applied stress increases, as illustrated in Fig. 6. For the samples oriented at 45° from the warp direction, the damage D reaches a value of 0.53 close to the final failure. However, for the 0° case, it only goes up to 0.1. The values of damage for every tested sample are summarized in Table 1. This damage estimation is employed as a first reference to validate the proposed ultrasonic damage indicators detailed in further sections. Indeed, as discussed, Fig. 6 indicates a higher amount of damage induce by the loading for the 45° configuration, which could imply different damage mechanisms with different associated typical scales. In fact, to investigate the sensitivity of the ultrasonic techniques, it is necessary to consider different scales of induced damage. Hence, the typical scale of those mechanisms for the two sample configuration requires further study.

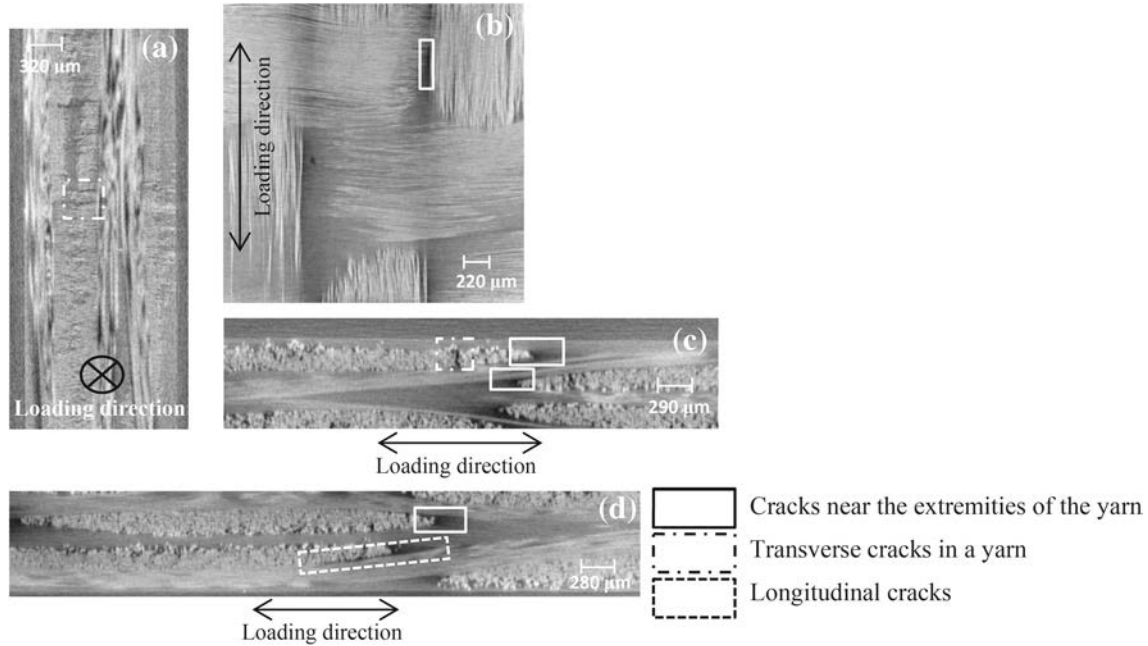
Fig. 10 Three main damage mechanisms identified for 0° sample configuration under tension loading. These main mechanisms consist in cracks near the extremities of the yarns, transverse cracks in yarns and longitudinal cracks

Some examples of damage mechanisms observed for samples in the 0° configuration are illustrated in Fig. 10. For tensile tests along the warp fiber axis, the main damage mechanisms observed were the formation of cracks near the end of the yarns (Fig. 10b, c, d), and transverse cracks inside the yarns (Fig. 10a, c), for example). Some longitudinal cracks that follow the transverse yarns very locally in the last step of damage were also observed (Fig. 10d). As the loading level increased, the number and the size of defects (cracks and voids) increased too (Tables 3, 4).

of 50 μm for the highest damaged samples. These longitudinal cracks can then propagate along the warp yarns as shown in Fig. 10d.

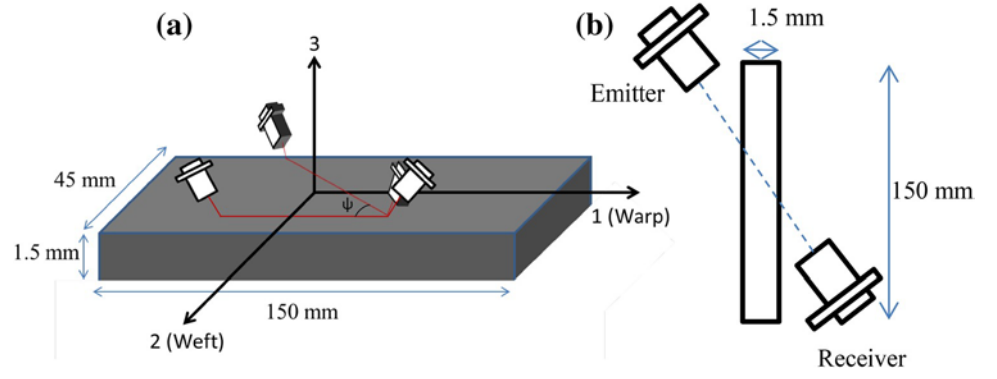
Fig. 15 Schematic representation of the two planes of interest: **a** the plane 1–2 or azimuth plane and **b** the plane 1–3

The composite is considered as orthotropic prior to loading and remains so even after the damage induced by the tensile loading. The elastic linear behavior of the composite can be described using nine stiffness components. However, considering the dimensions of the sample, only measurements in two principal planes were performed as illustrated in Fig.

15. These measurements only permitted obtaining seven out of nine stiffness components. It was observed that along the plane 1–3, quasi longitudinal and quasi transversal mode 1 can be measured. For the plane 1–2, on which guided waves propagate, the frequency and phase velocity of the transmitted signal was measured. Consequently, after comparison with the dispersion curves in Fig. 16, the mode S2 was propagating in the composite.

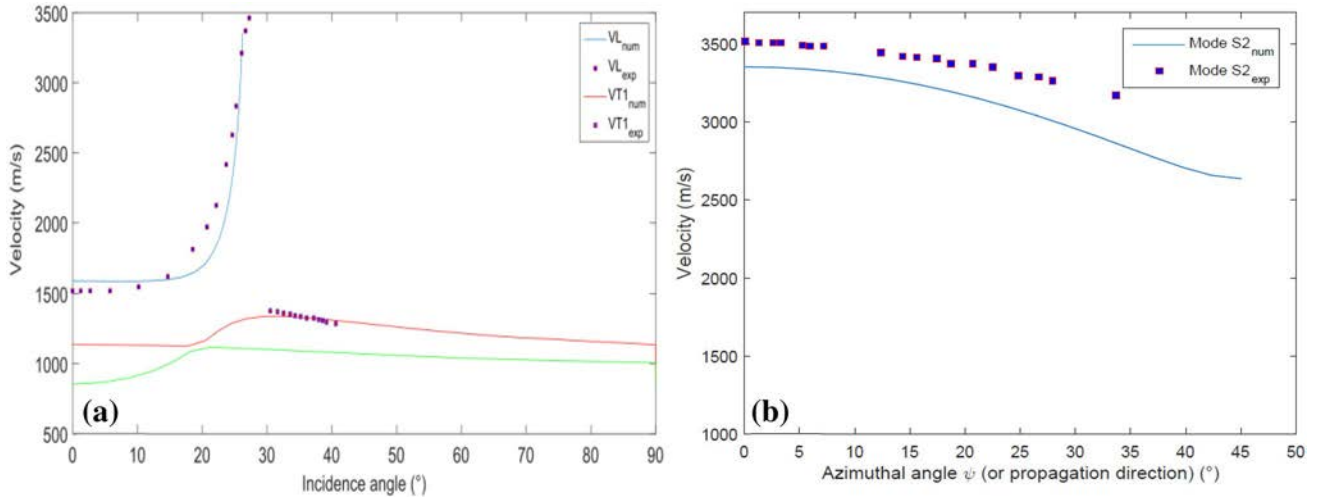
Fig. 18 Comparison of numerically and experimentally determined propagation wave velocities. The experimental values are represented by points whereas numerical values are represented in continuous line. **a** Plane 1–3; **b** Plane 1–2 or azimuth plane

Before running the optimization procedure for obtaining the stiffness constants, a computation of the expected velocity as a function of the incidence angle was performed. The quasi longitudinal, the quasi transversal 1 and the quasi transversal 2 modes propagated in the 1-3 principle plane were calculated for a refraction angle ranging from 0 to 90°. This computation was based on the stiffness matrix obtained by periodic

homogenization (Table 5). The computed velocities were compared to those obtained experimentally for the undamaged sample. The same calculation was made for Lamb wave propagation in the 1-2 planes, more particularly for the S2 mode. The comparison of experimental and analytical velocities of wave propagation is illustrated in Fig. 18. It confirms that the mode experimentally measured corresponds to the actual wave mode that was assumed to propagate in the composite material.

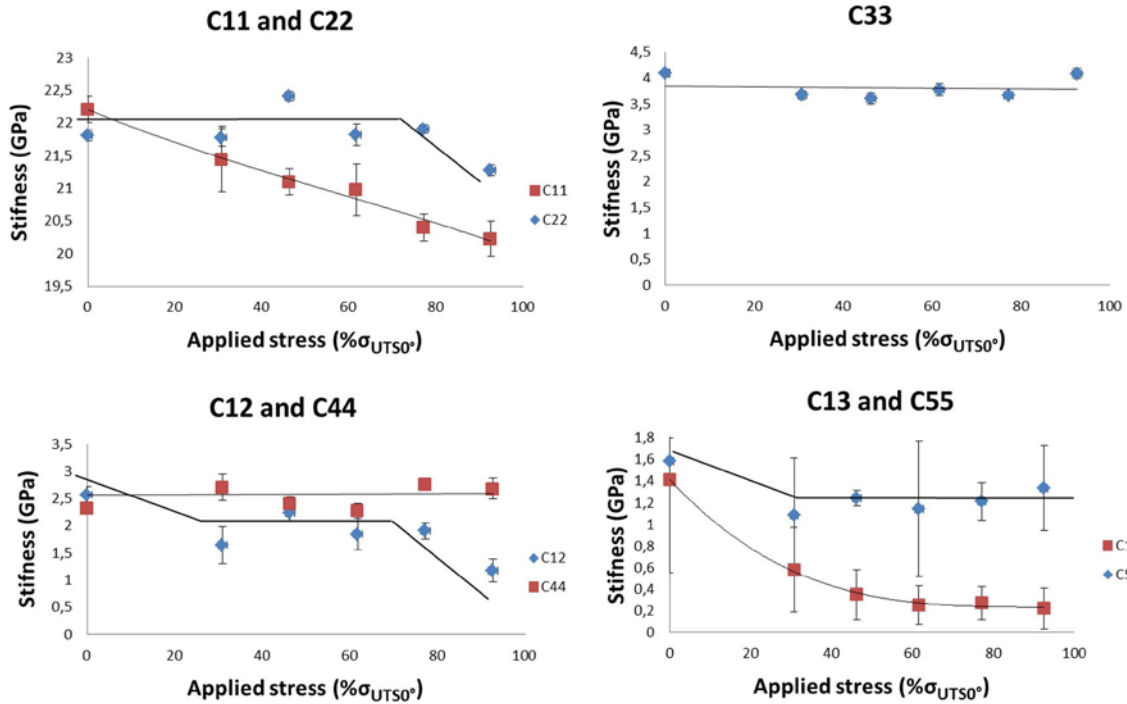
Fig. 19 Evolution of seven of the stiffness constants, function of the tensile stress, with the increase of the loading for the 0° configuration of sample with their respective confidence interval

For the undamaged sample oriented along the warp direction (0°), the experimental stiffness constants were close to the numerically obtained results as observed in Table 5. The evolution of the stiffness constants is plotted in the Fig. 19 with their respective confidence interval. Furthermore, it was noticed that the global evolution of the stiffness components was close to the results discussed by Hufenbach et al. [9]. An important decrease of the components C_{11} and C_{13} was noticed, whereas a smaller decrease of C_{12} and C_{55} and

One can then conclude that the components depending on the loading direction (direction 1), namely C_{11} and C_{13} were more affected by the damage. The component C_{12} was also impacted by the damage but at a lower extent.

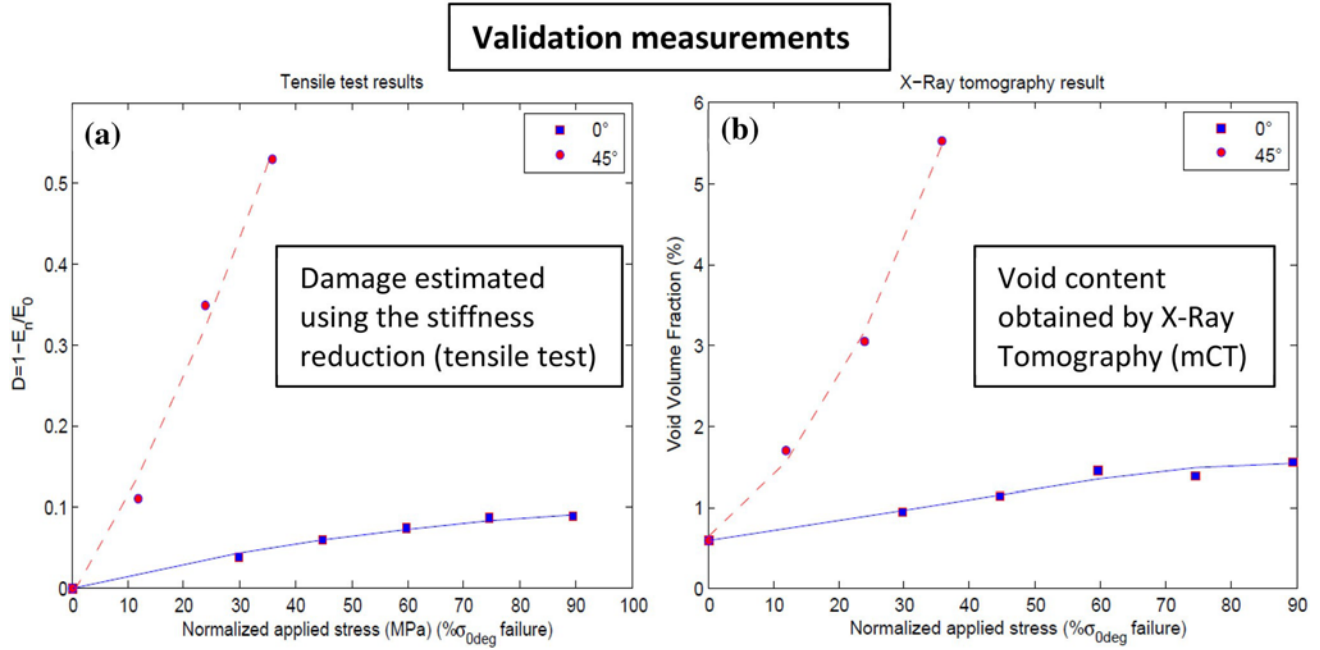
Fig. 26 Damage indicators used as validation tools. **a** Damage estimated on the elastic modulus reduction and **b** Void volume fraction. Those indicators are plotted for the sets of samples oriented at 0° and 45° from the warp direction and function of the normalized applied stress level
